PROVING PERFORMANCE HAANA WELDED FROGS

THE BACKGROUND

Over the last five years, Holland has repaired over 350 frogs via automated welding on multiple Class 1 and Short Line railroads. When a selection of repairs on a Class 1 was evaluated over three years later, the HAMR welded frogs demonstrated superior performance to traditionally repaired frogs and are continuing to exceed expectations.

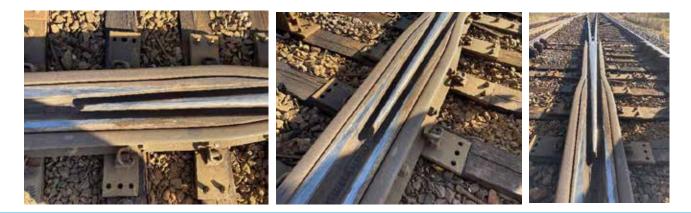
Date of repair	Serial #	Frog Type		Location	Track		-	Material Used lbs			MGT Rate per day	
6/24/2019	1748	RBM	GENEVA	CPY055	2	West	5	19.88	11/8/2022	1233.00	0.15	184.95

Condition: Fair/Good. Cracking 10" back w/ flow; Riding good; Missing fasteners & broken tie plate.

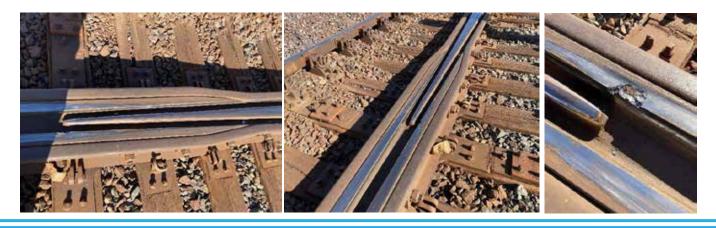
Date of repair	Serial #	Frog Type		Location	Track	•	Material Used lbs				
ſ	7/31/2019	464	RBM	GENEVA	CPY080	2	4	13.2	11/8/2022	1196.00	0.15	179.40

Condition: Good. Chip on mainline wing; Riding good.
