# HAMR<sup>TM</sup>

Holland Automated Manganese Refurbishment

## CROSSING DIAMOND CASE STUDY

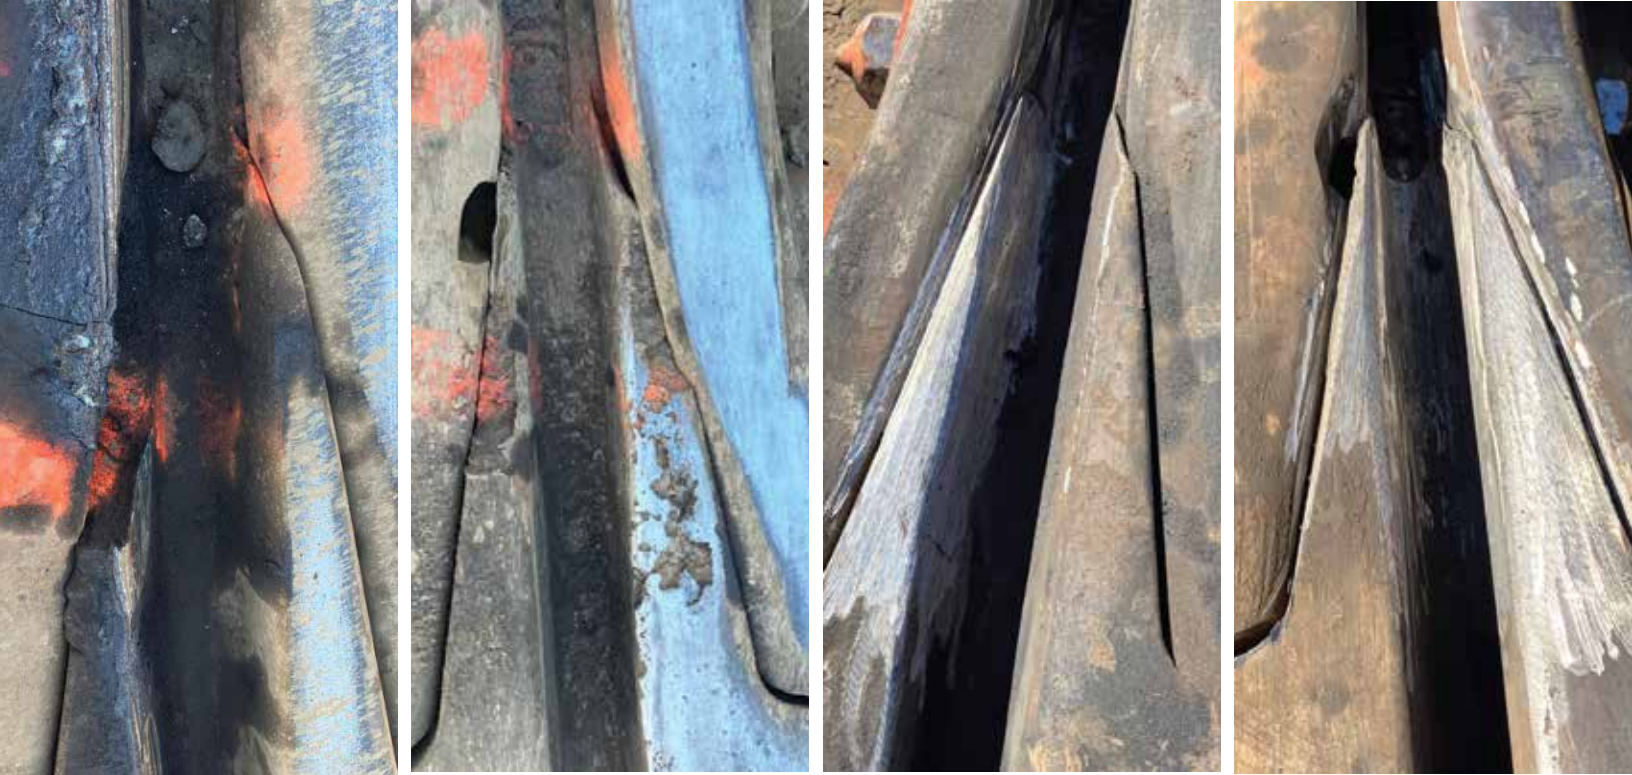
A Class 1 railroad had crossing diamonds with FRA violations. Limited available track time coupled with the severity of the damage made it infeasible to repair the diamonds in track with traditional manual welding procedures. Replacing the diamonds would also require extensive track time, planning, and work crews to result in an expensive repair. The customer contacted Holland to investigate how we could help.

Holland's Automated Manganese Refurbishment (HAMR™) service includes pre-weld material removal using plasma cutting and robotically controlled welding procedures to build back the damaged areas on specialty components such as rail frogs and diamonds. After damaged areas are built back up, our teams then finish grind components to bring them back to OEM specifications.

In this situation, Holland utilized its HAMR-4 mobile manganese repair truck to conduct in-track repairs for the customer. Holland's newly designed truck features a deployment method that allows us to begin welding in under 5 minutes. The speed of this new process makes it ideal for working either in-track or alongside track under Form B protection.

Additionally, Holland's robotically controlled welding process deposits material 3-4x faster than manual welding. In addition, this process has been designed to limit the heat input to keep manganese components under 500 degrees. Utilizing this technology, Holland was able to repair all 4 diamond inserts for the customer, eliminating FRA violations faster and more cost-effectively than originally thought possible.
